## 1.0 Ambrosia Lake, New Mexico, Disposal Site

### 1.1 Compliance Summary

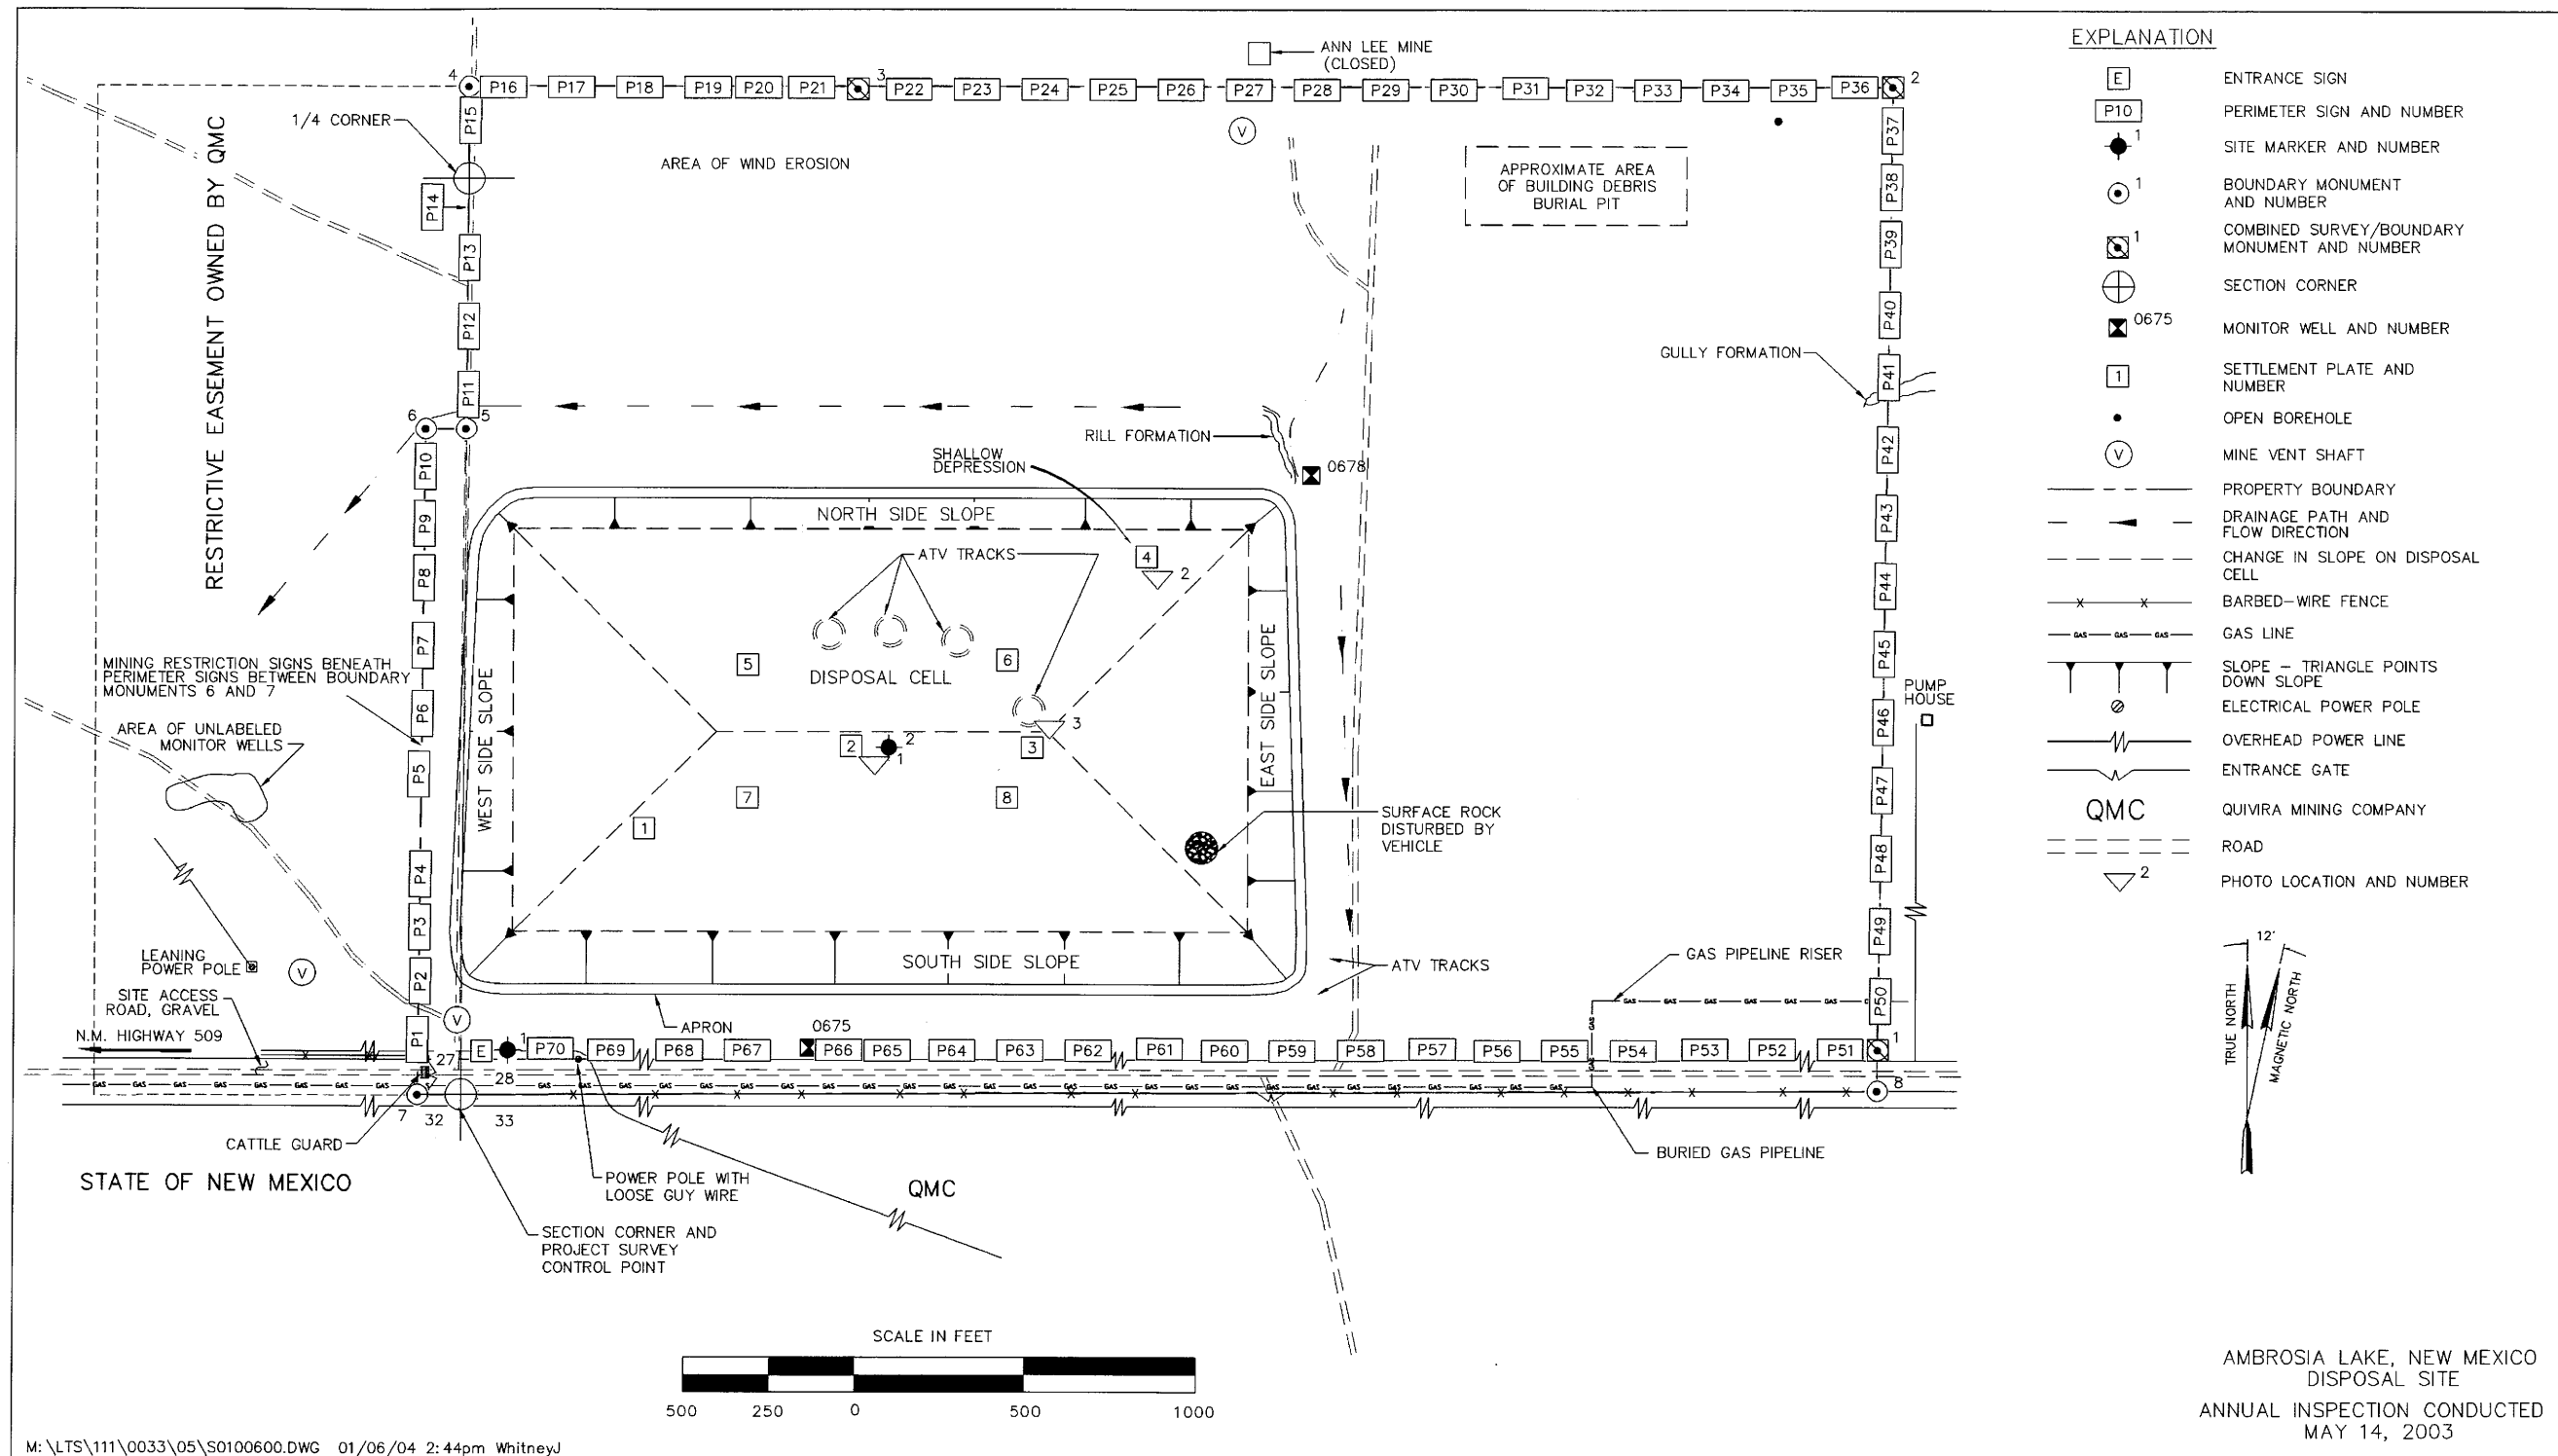
Trespassing was evident on top of the disposal cell. An all-terrain vehicle (ATV) had been driven to the top of the cell and used to mark four circles with diameters between 40 and 60 feet (PL-3). Another area of surface disturbance was noted near the southeast corner of the cell top. The tracks were very shallow and do not impair the integrity or performance of the cover.
